SNS Home Inspections LLC

Property Inspection Report

123 Anywhere Dr, Orlando, FL 12345
Inspection prepared for: Donald Duck
Real Estate Agent: -

Date of Inspection: 2/20/2015 Time: 9:00 AM
Age of Home: 2009 Size: 3424 sq ft
Weather: sunny
Order ID: 5261

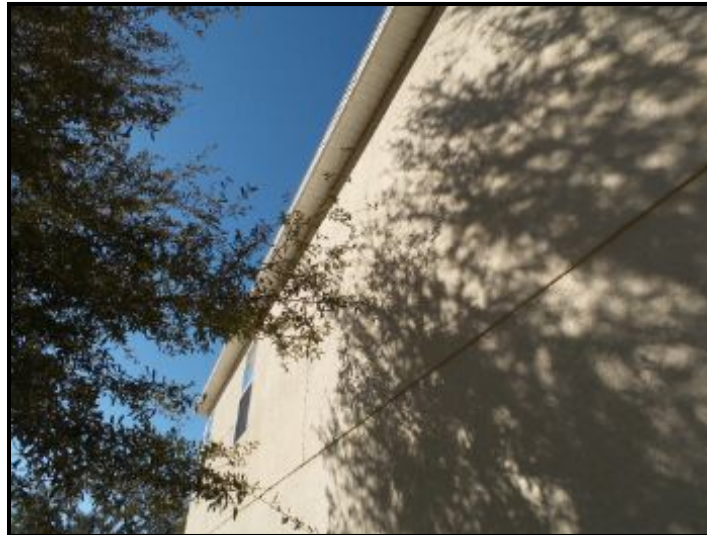
Tree limbs within 10 feet of roof should be trimmed away to provide air and sunlight to roof, while minimizing debris & dampness.

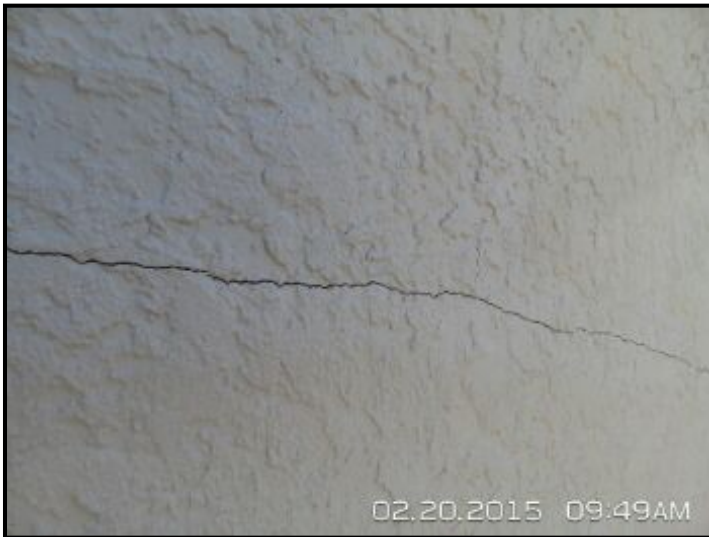
Cracking observed at several areas around home. Appears to have been repaired once already and has cracked again. This is a sign of possible continuous movement. Cracking of this type is possible source of moisture entering into the walls. Recommend licensed contractor evaluate and make recommendations for repairs.

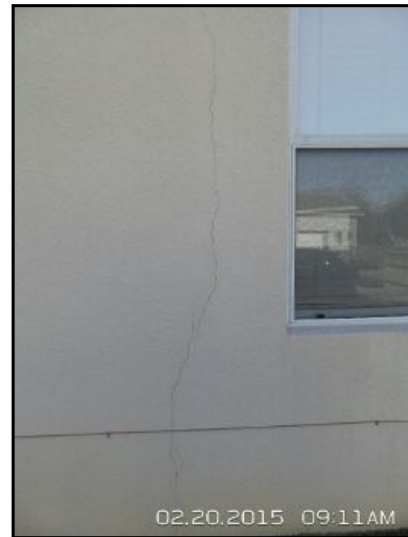
Cracking observed at several areas around home. Appears to have been repaired once already and has cracked again. This is a sign of possible continuous movement. Cracking of this type is possible source of moisture entering into the walls. Recommend licensed contractor evaluate and make recommendations for repairs.

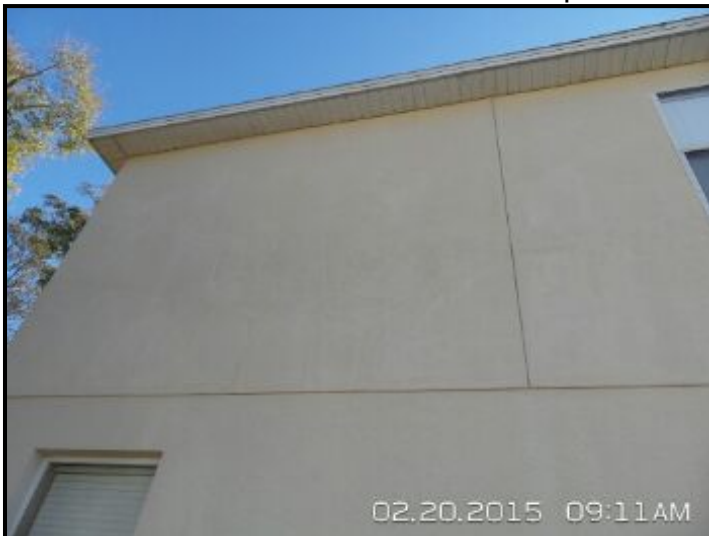
Cracking observed at several areas around home. Appears to have been repaired once already and has cracked again. This is a sign of possible continuous movement. Cracking of this type is possible source of moisture entering into the walls. Recommend licensed contractor evaluate and make recommendations for repairs.

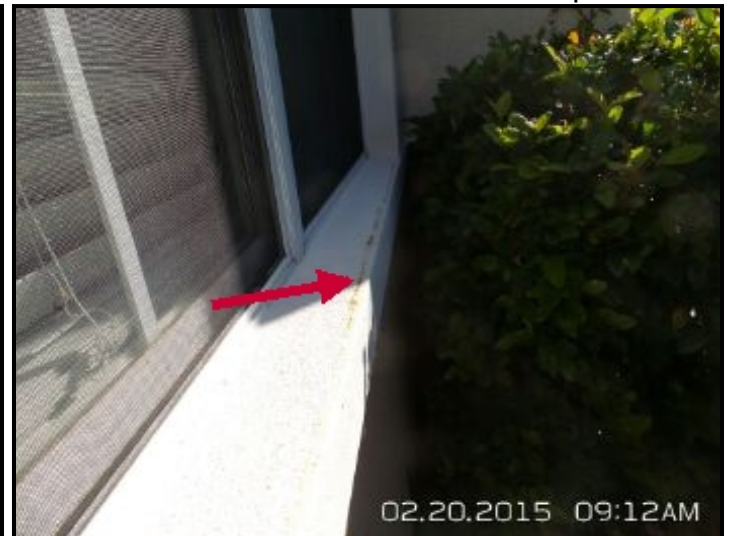
Areas of stucco show rust and deterioration of underlying metal corners. This is a sign of possible moisture in the wall space. Recommend licensed contractor evaluate and make recommendations for repairs.

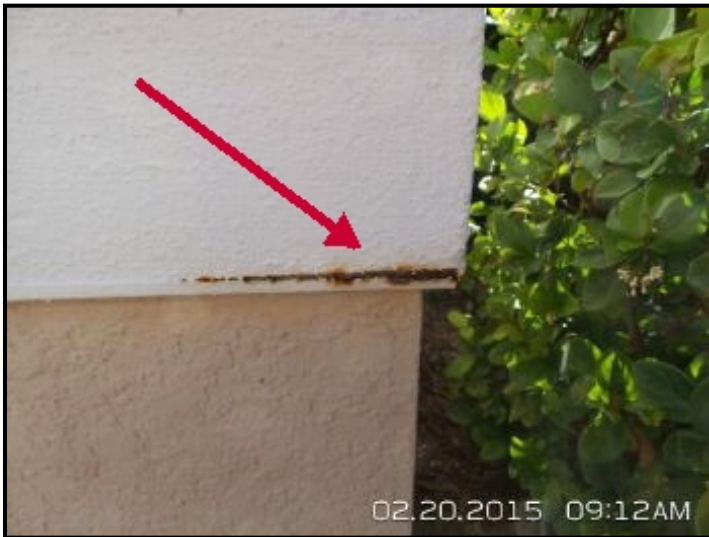
Areas of stucco show rust and deterioration of underlying metal corners. This is a sign of possible moisture in the wall space. Recommend licensed contractor evaluate and make recommendations for repairs.

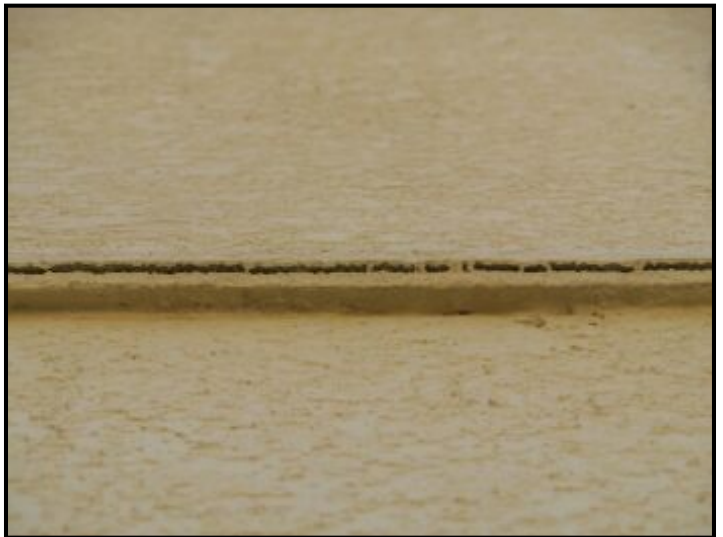
Cracking observed at several areas around home. Appears to have been repaired once already and has cracked again. This is a sign of possible continuous movement. Cracking of this type is possible source of moisture entering into the walls. Recommend licensed contractor evaluate and make recommendations for repairs.

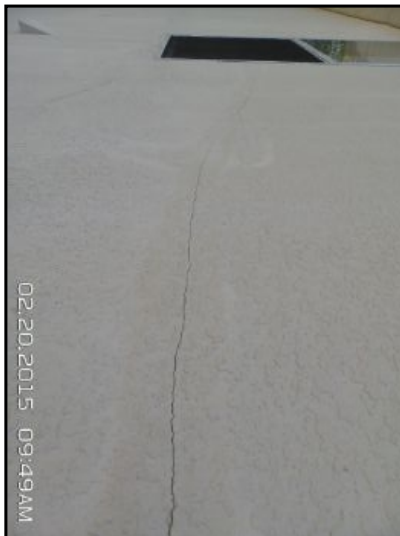
Cracking observed at several areas around home. Appears to have been repaired once already and has cracked again. This is a sign of possible continuous movement. Cracking of this type is possible source of moisture entering into the walls. Recommend licensed contractor evaluate and make recommendations for repairs.

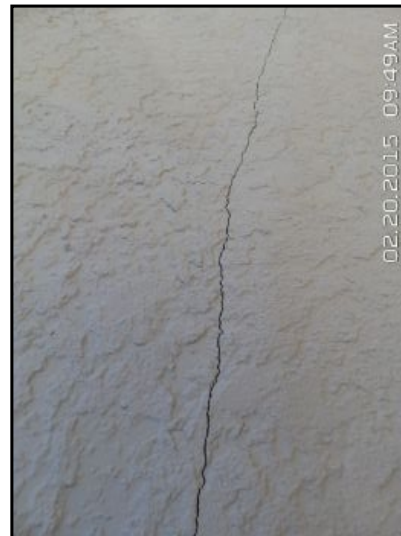
Cracking observed at several areas around home. Appears to have been repaired once already and has cracked again. This is a sign of possible continuous movement. Cracking of this type is possible source of moisture entering into the walls. Recommend licensed contractor evaluate and make recommendations for repairs.

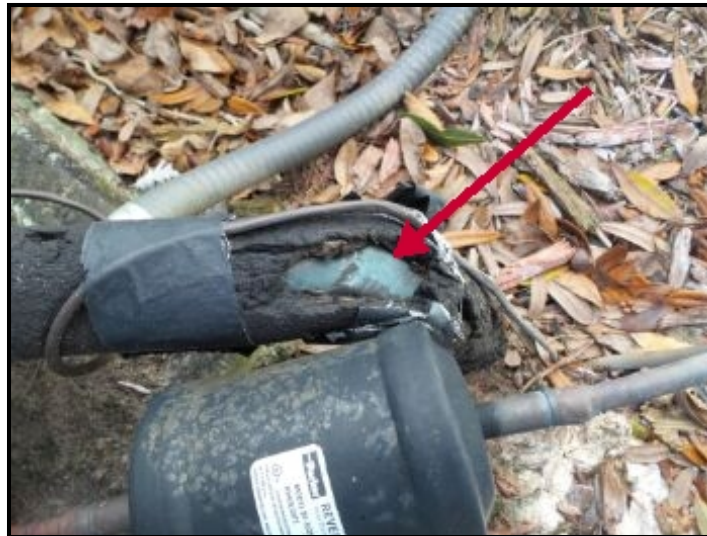
Missing insulation at A/C unit.

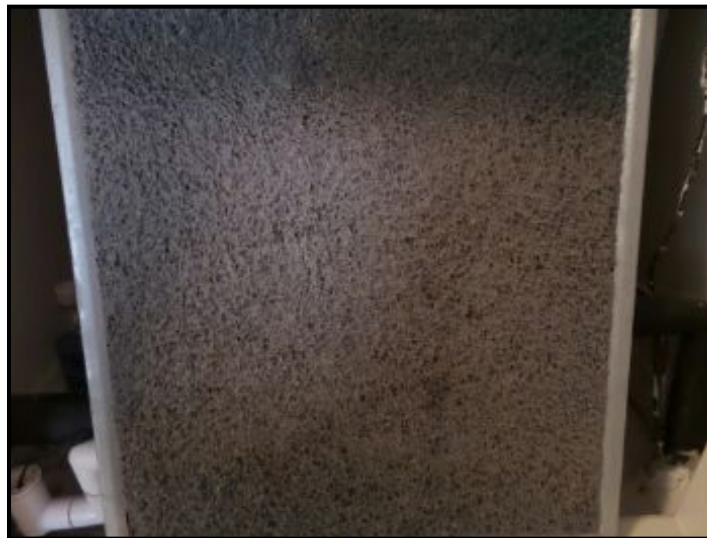
Filter dirty. Needs replacement.

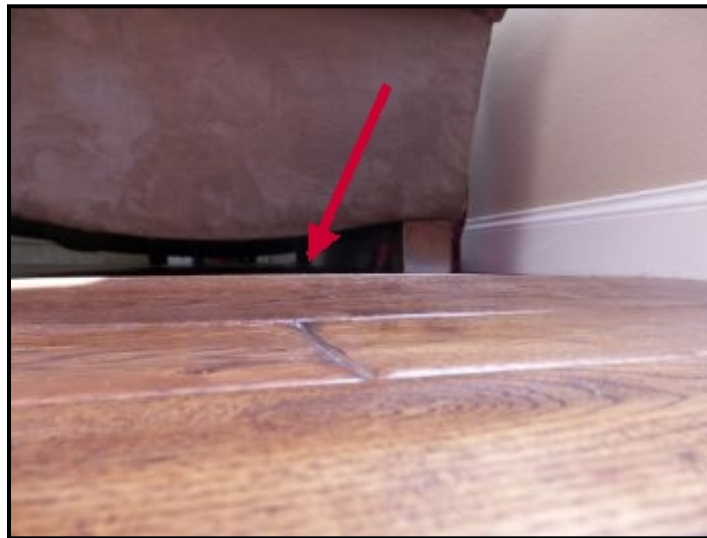
Popping floor observed. This is usually caused by poor installation practices or excessive moisture. Floor was tested for moisture and appeared dry at time of inspection.

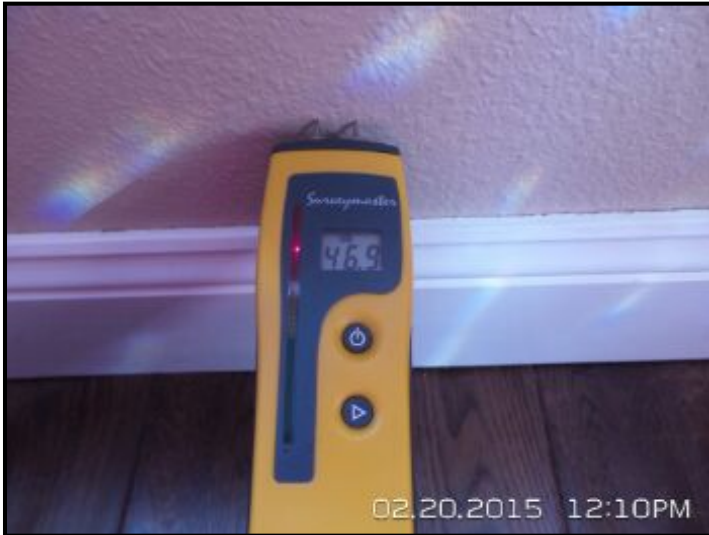
There is evidence of moisture entering structure. Moisture readings were taken in the southwest corner of living room and found to be elevated. Recommend licensed contractor evaluate and determine what the cause is and make repairs.

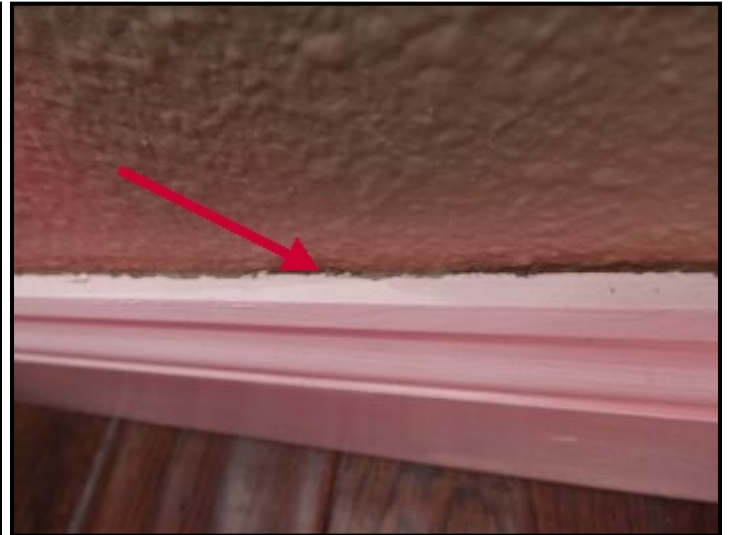
Base moldings are warping and pulling away from wall in the southwest corner of living room.

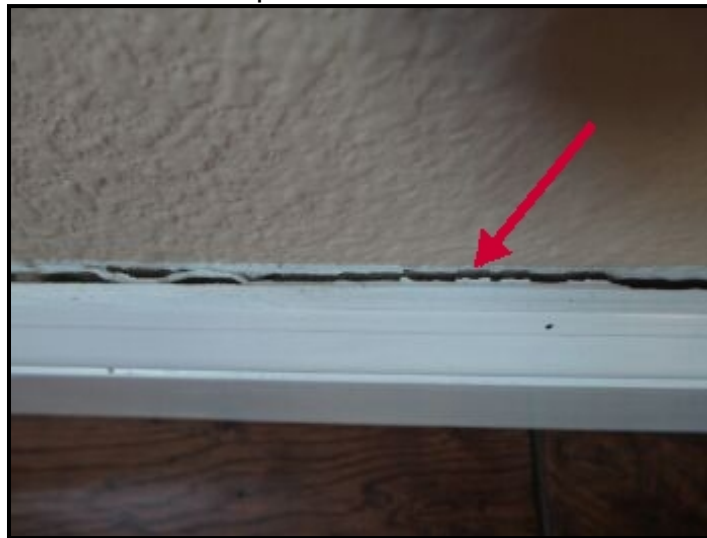
Base moldings are warping and pulling away from wall in the southwest corner of living room.

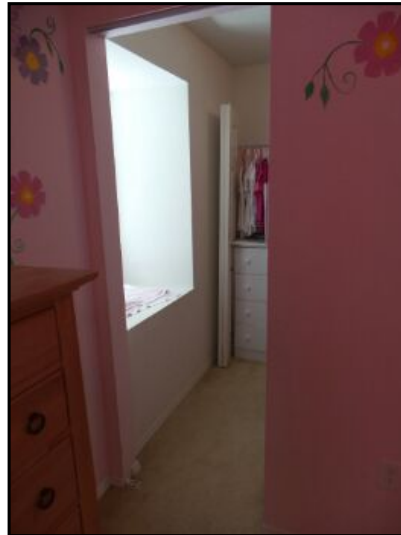
Closet door has fallen off.

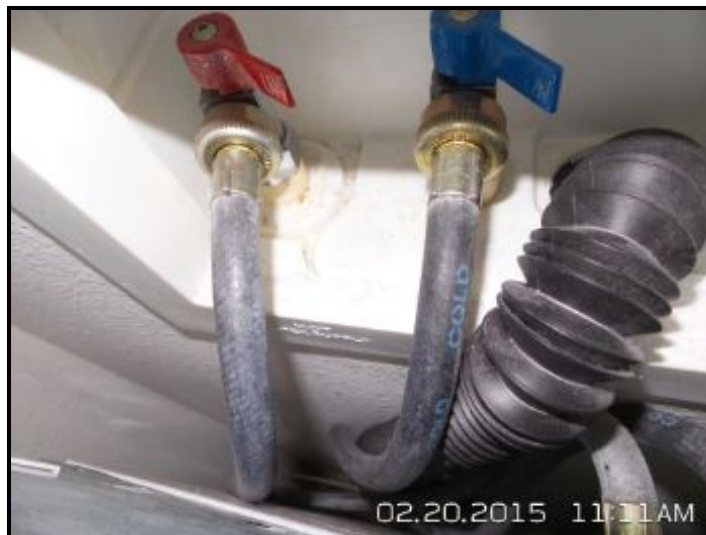
Rubber washer supply lines noted. This is not a major concern, just monitor them. They have been known to rupture. Recommend replacement with reinforced braided steel lines.

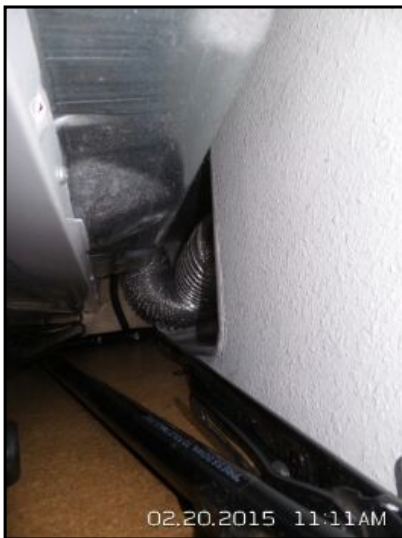
The dryer vent is of flexible type, this type of vent has been known to clog easily and could pose a fire hazard. Recommend replacement with rigid vent pipe.

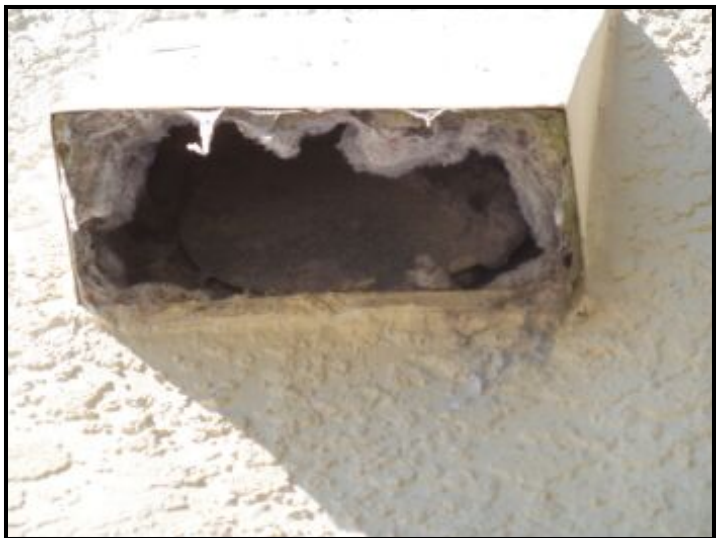
Large amounts of lint noted in dryer vent. Recommend cleaning to insure safe and efficient operation.

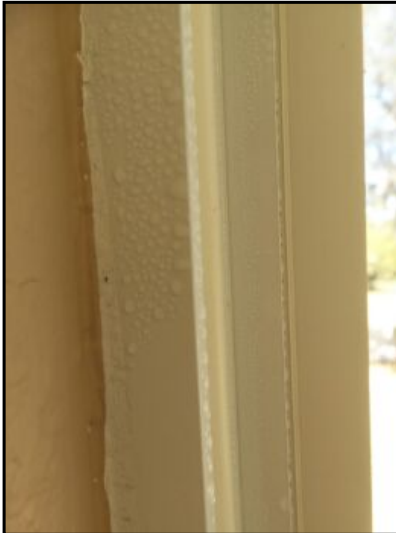
Home appears to have high moisture levels. Large amounts of condensation was observed on windows. Recommend licensed HVAC contractor evaluate and make recommendations for repairs.
