SNS Home Inspections LLC

Property Inspection Report

Inspection Address: 11234 Snow White Dr Disney World 12345

Date: 1/1/2022

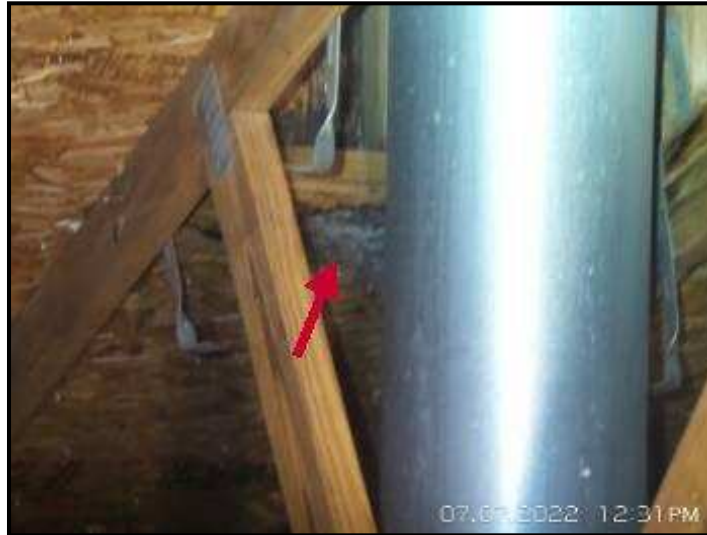
Evidence of past or present leaks and wood rot observed. Area appeared to be dry at the time of inspection. Recommend further evaluation by a qualified contractor.

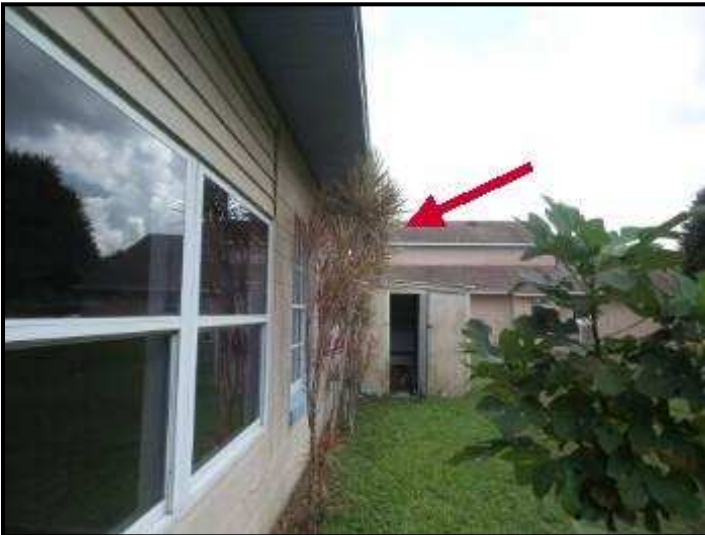
Prune or remove any plants that are in contact or proximity to home to eliminate pathways of wood destroying insects.

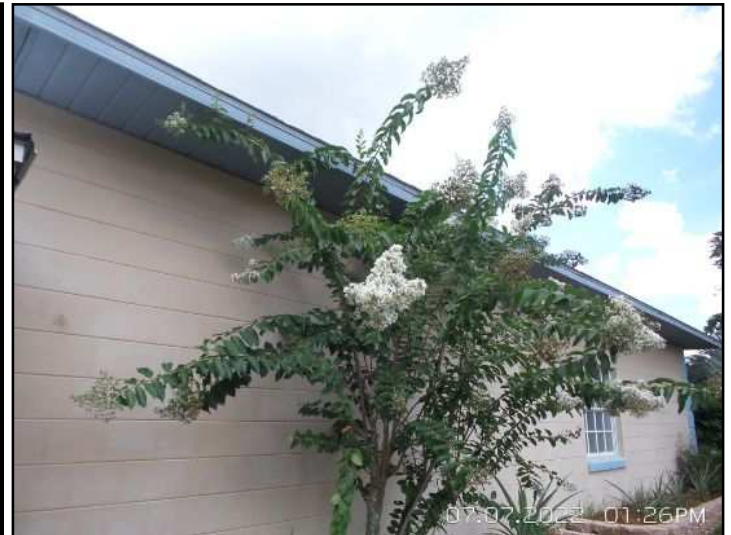
Prune or remove any plants that are in contact or proximity to home to eliminate pathways of wood destroying insects.

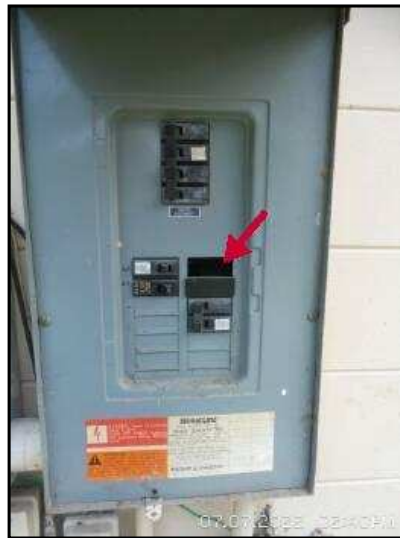
Open breaker panel slot(s) at panel box cover. Electrocutation hazard.

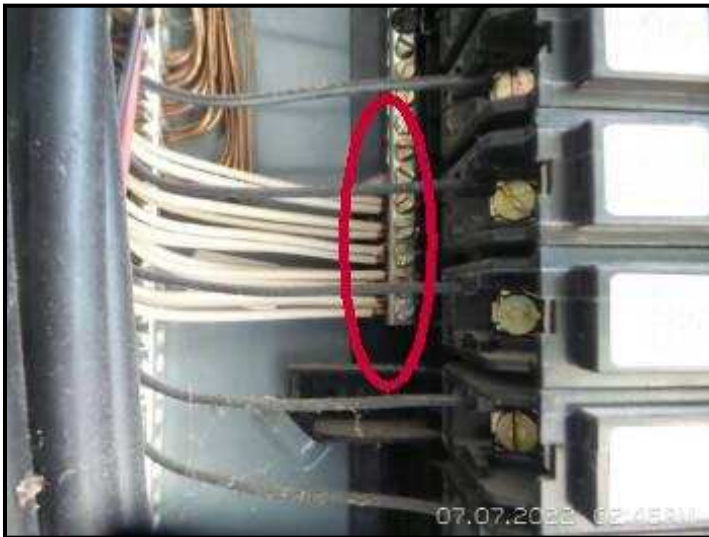
Double tapped connections inside panel box (more than one electrical conductor attached to a single screw and/or lug). This is not standard practice, and may cause overheating or even an electrical fire. Recommend evaluation by an electrician.

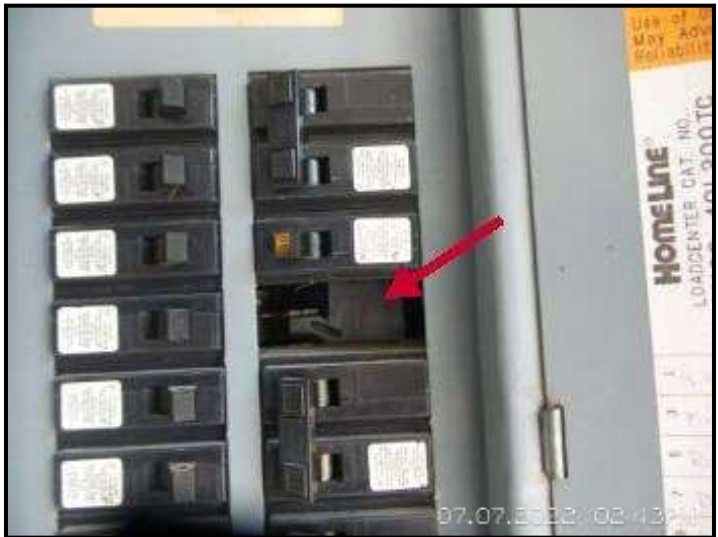
Open breaker panel slot(s) at panel box cover. Electrocutation hazard.

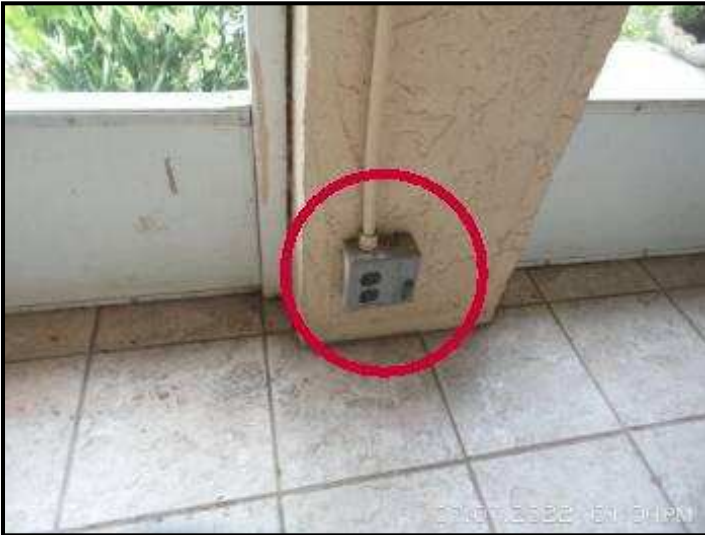
Outlet at the front porch did not have power.

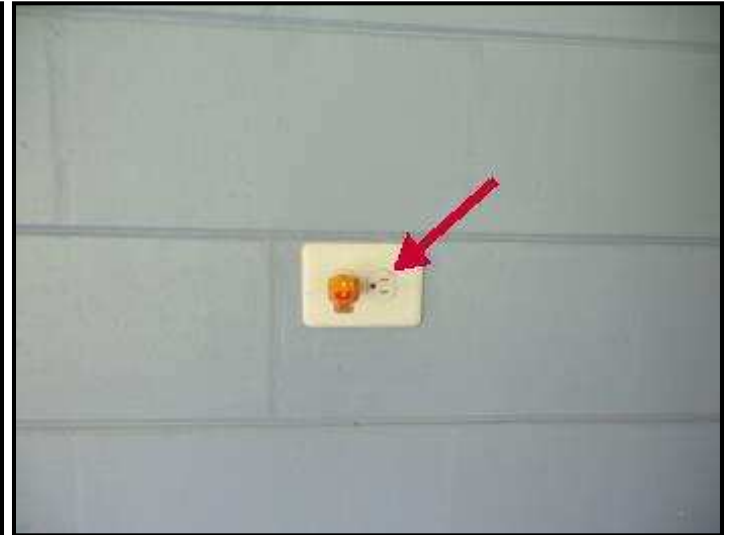
Reversed polarity, hot and neutral reversed and other terms used for electric receptacles are usually easily corrected by minor wiring adjustments at the specified item. When these conditions are noted in this report, a licensed electrician should be consulted for repairs/replacement as needed to ensure safety.

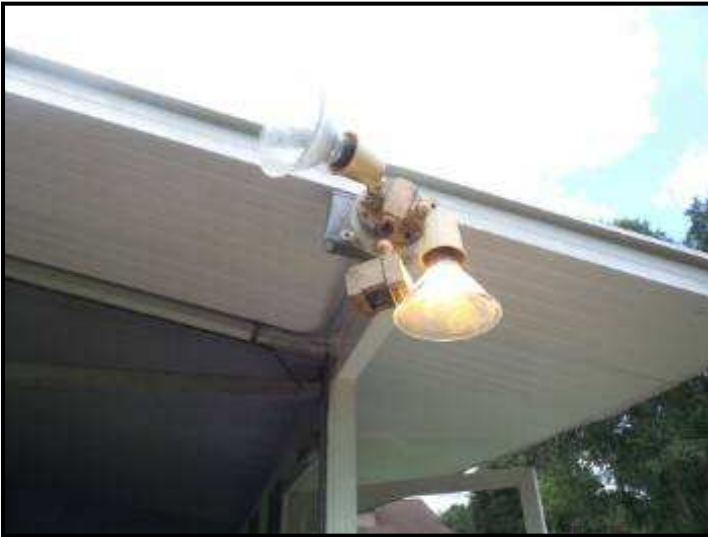
Damaged light fixtures observed.

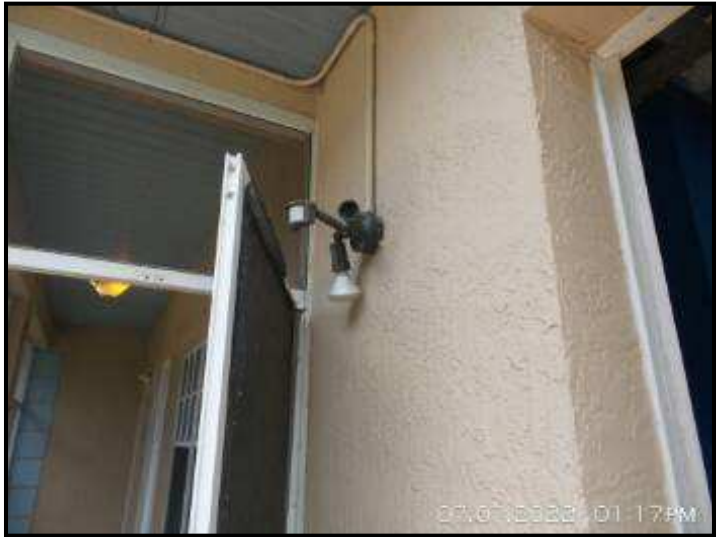
Damaged light fixtures observed.

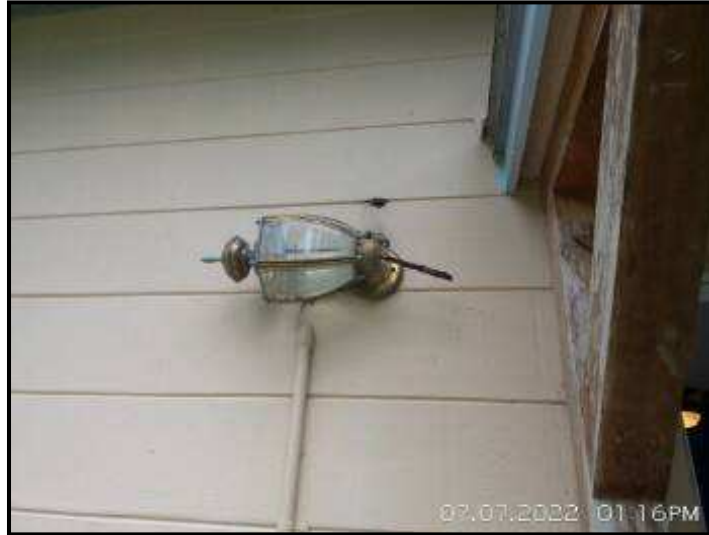
Damaged light fixtures observed.

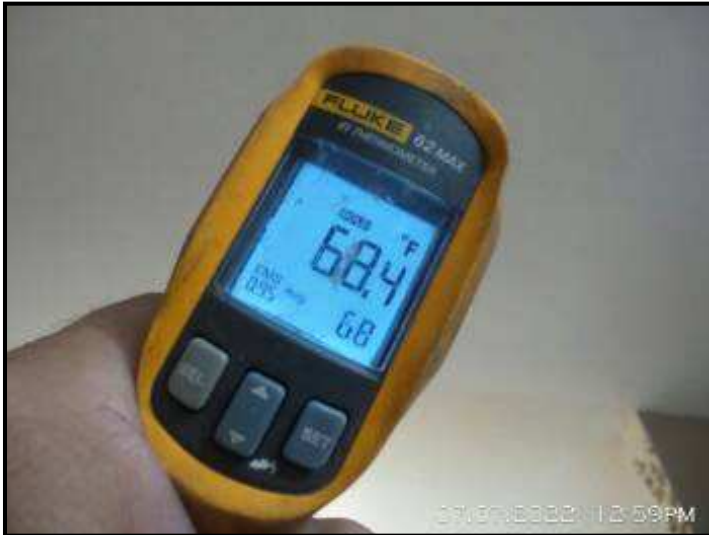
The air conditioner did not cool the home properly. Recommend **HVAC** contractor evaluate and repair the system.

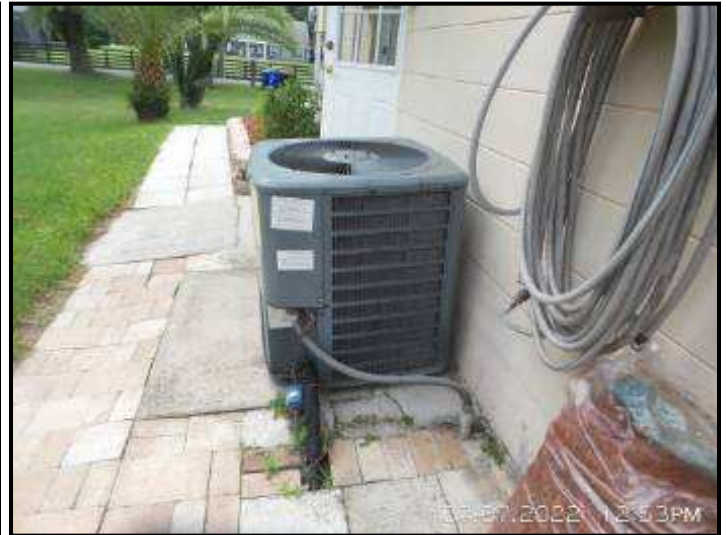
Exterior unit not level. This can affect system performance.

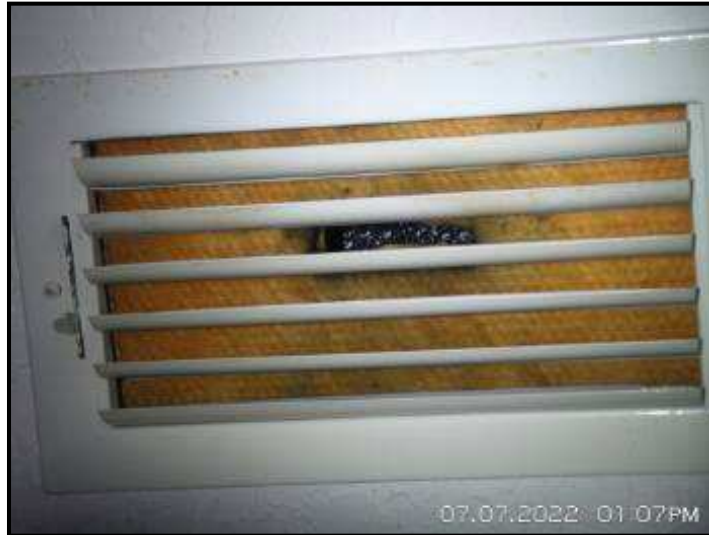
Air flow weak at multiple registers. We recommend further evaluation by a licensed HVAC technician. Some registers have the air flow restricted.

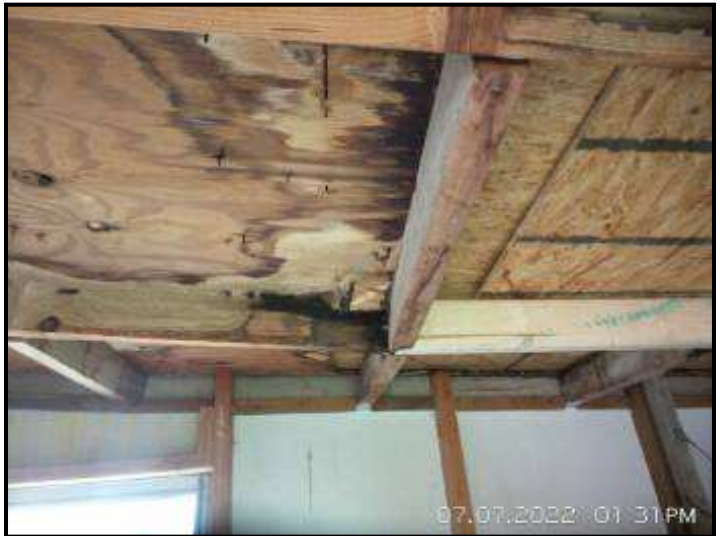
Exterior closet that contains the water treatment system shows signs of significant wood rot. It appears to be near the end of its useful life. Recommend replacement.

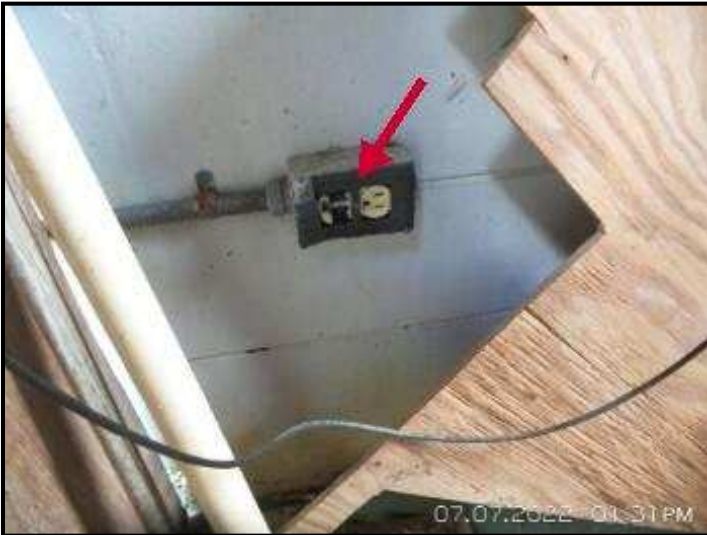
Damaged electrical outlet observed in the exterior closet.

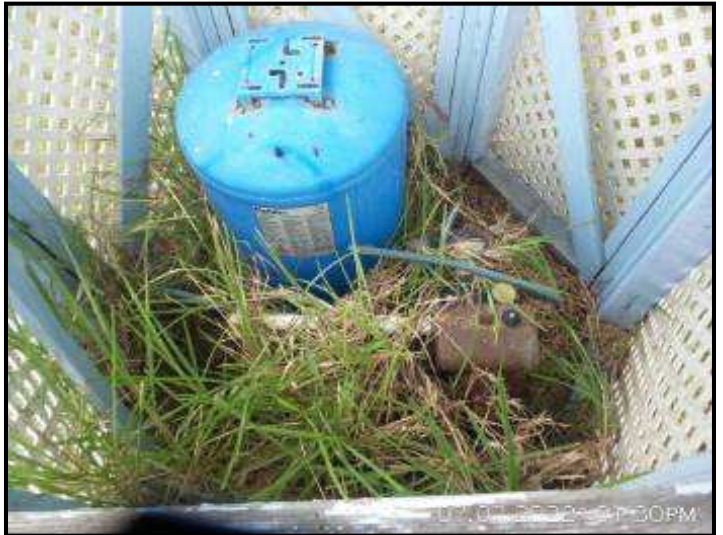
There is a well pump present in the backyard. It appears that the home was on a well at some point. This system does not appear to be in service at this time. Recommend further evaluation by a qualified contractor if buyer would like to use this for irrigation possibly.

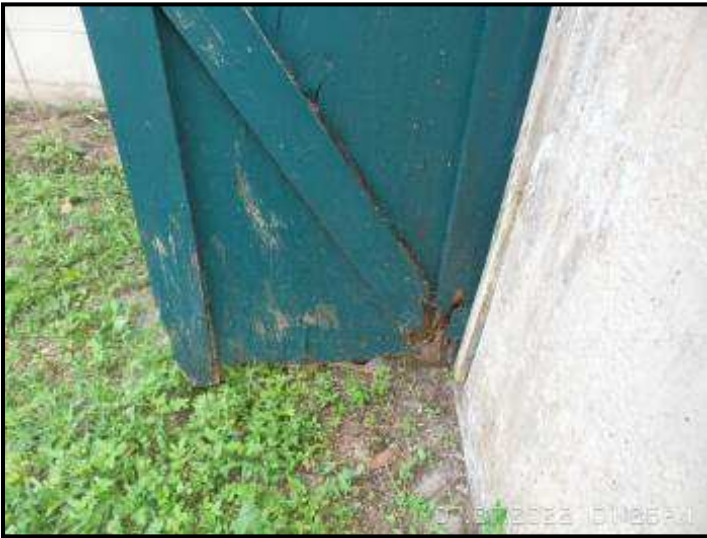
Exterior closet that contains the water treatment system shows signs of significant wood rot. It appears to be near the end of its useful life. Recommend replacement.

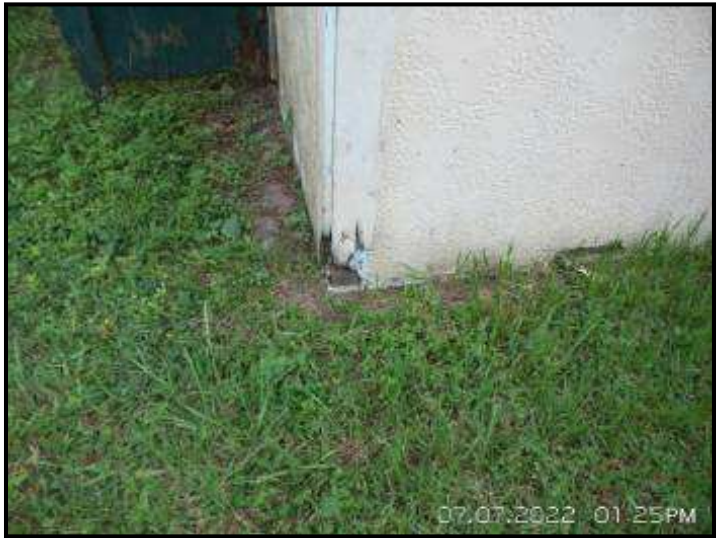
Exterior closet that contains the water treatment system shows signs of significant wood rot. It appears to be near the end of its useful life. Recommend replacement.

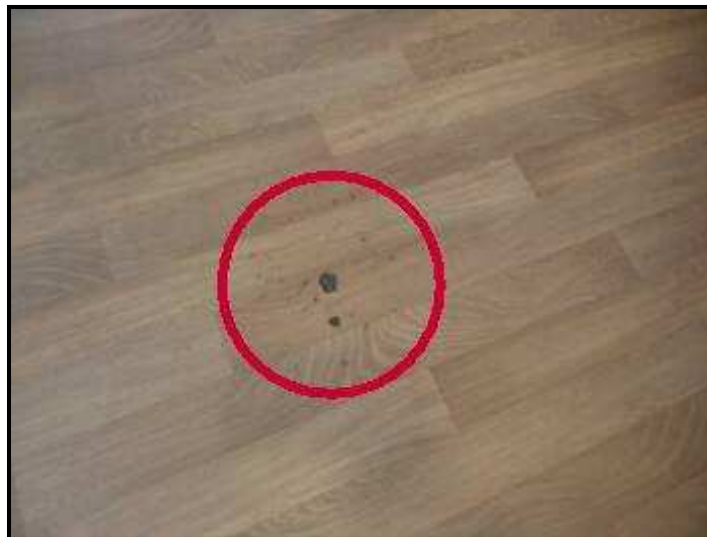
Minor damage noted.

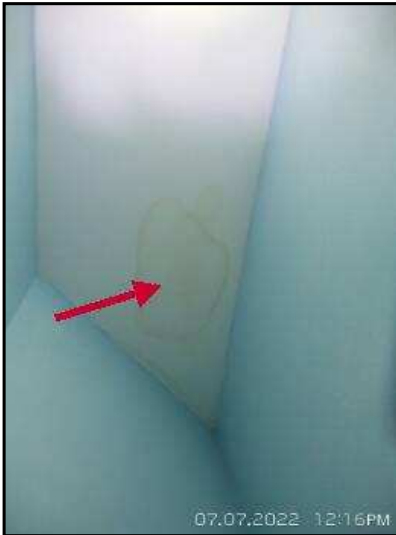
Stains were present on the closet ceilings indicating prior water infiltration. Although they tested dry they should be noted.

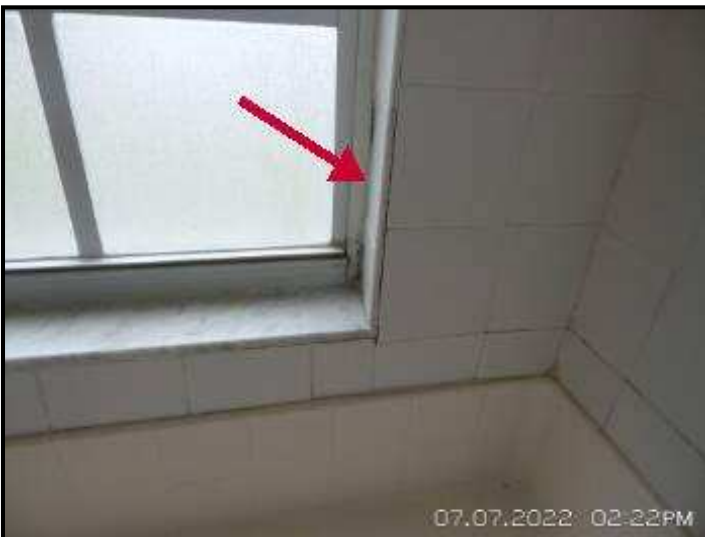
Loose tiles noted. Recommend review by a licensed contractor for repair or replacement.

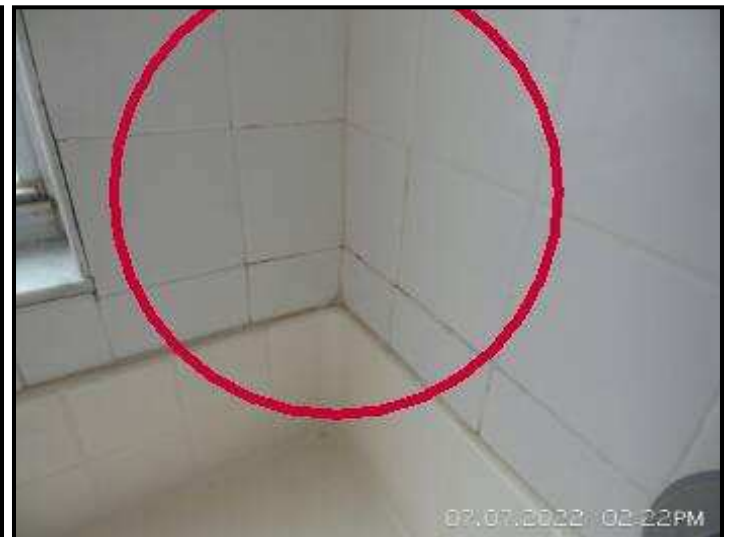
Loose tiles noted. Recommend review by a licensed contractor for repair or replacement.

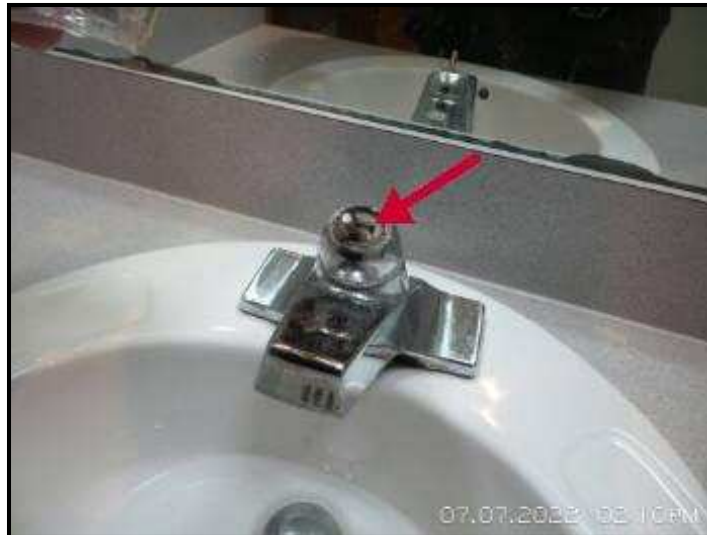
Faucet handle is loose.

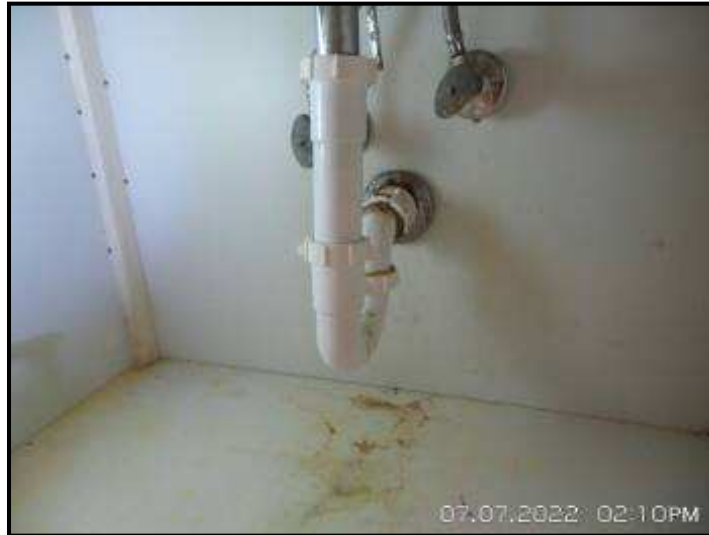
Drain line leaks under sink.

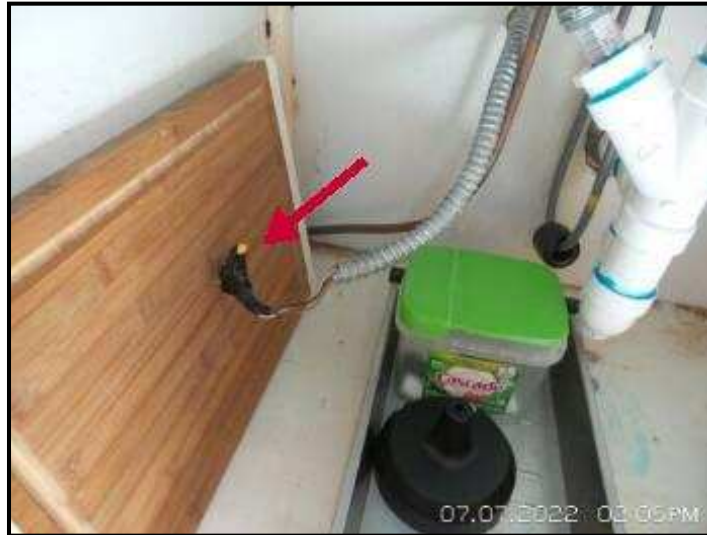
Exposed wiring observed under the sink.

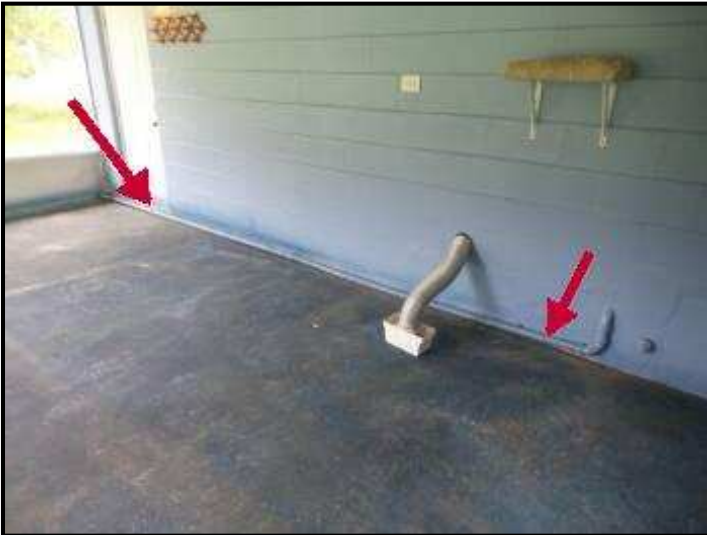
Washing machine drains outside on ground. This is an improper means of disposing of washing machine waste water, washing machine should drain into proper septic or sewer lines. Recommend a licensed plumber evaluate and suggest repair options.

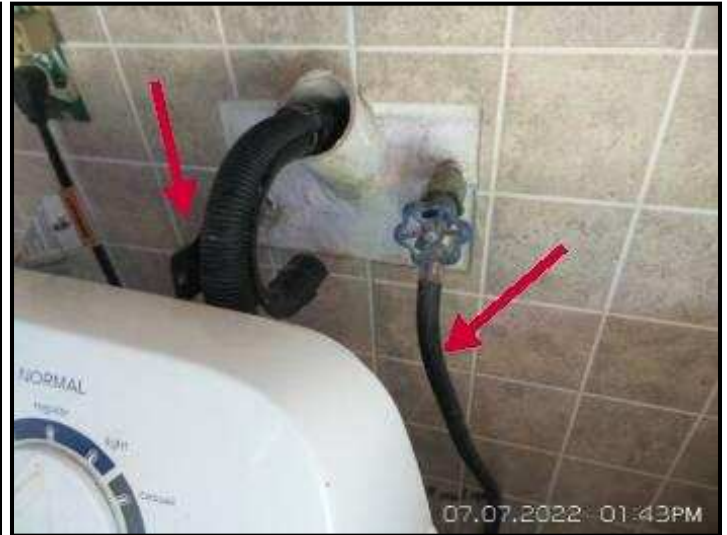
Rubber washer supply lines noted. They have been known to rupture. Recommend replacement with reinforced braided steel lines.

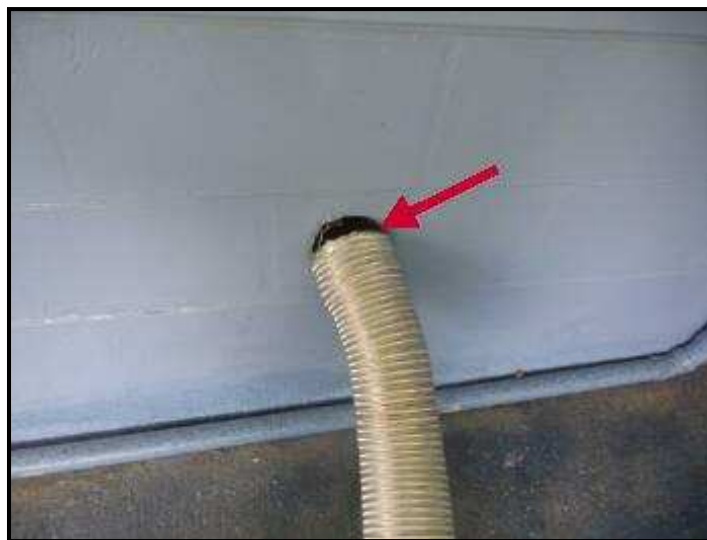
The dryer vent pipe is damaged.
